Multnomah County Willamette River Bridges Capital Improvement Plan

Seismic Vulnerabilities and Retrofit Report

*David Evans and Associates
2100 SW River Parkway
Portland, OR 97201
503 223-6663*

Dated: November 9, 2014

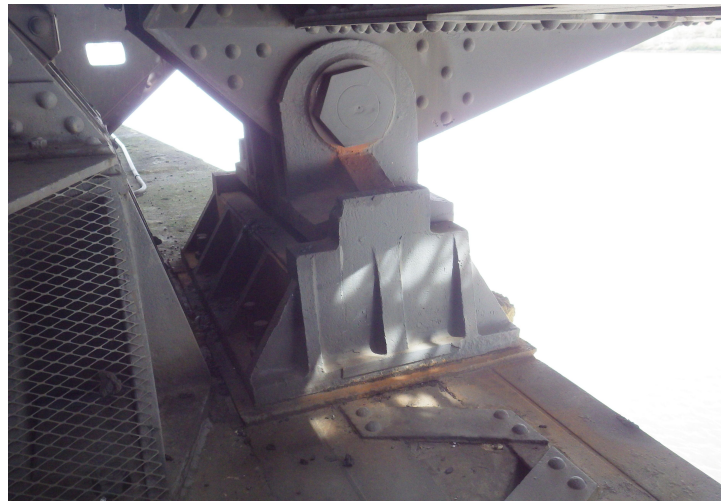
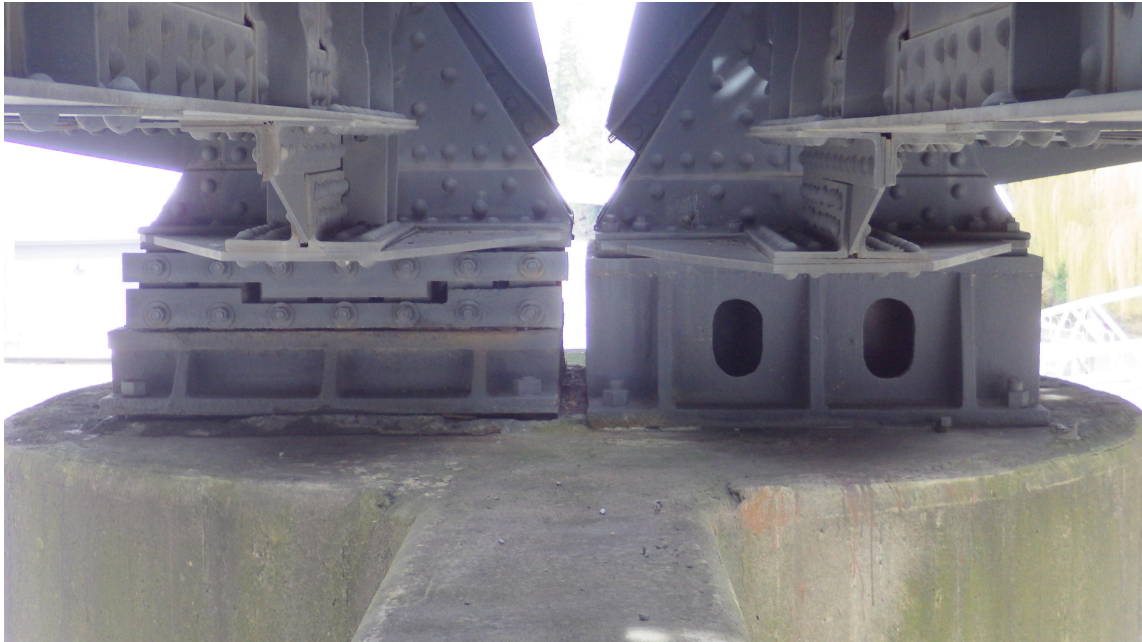
Figure MR031: Deck support columns at pit span
